**AIRCRAFT
ACCIDENT INVESTIGATION BOARD
REPORT**

**US ARMY UH-60
BLACK HAWK HELICOPTERS
87-26000 AND 88-26060**

TECHNICAL REPORT F-15 MAINTENANCE

Aircraft Evaluated: F-15C, Tail Number 79-0025

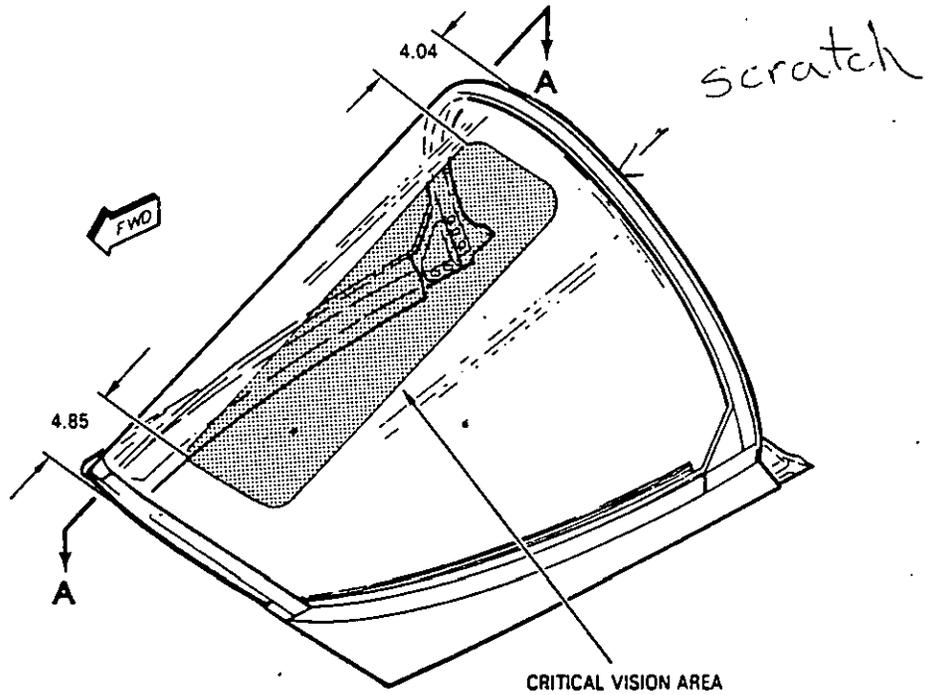
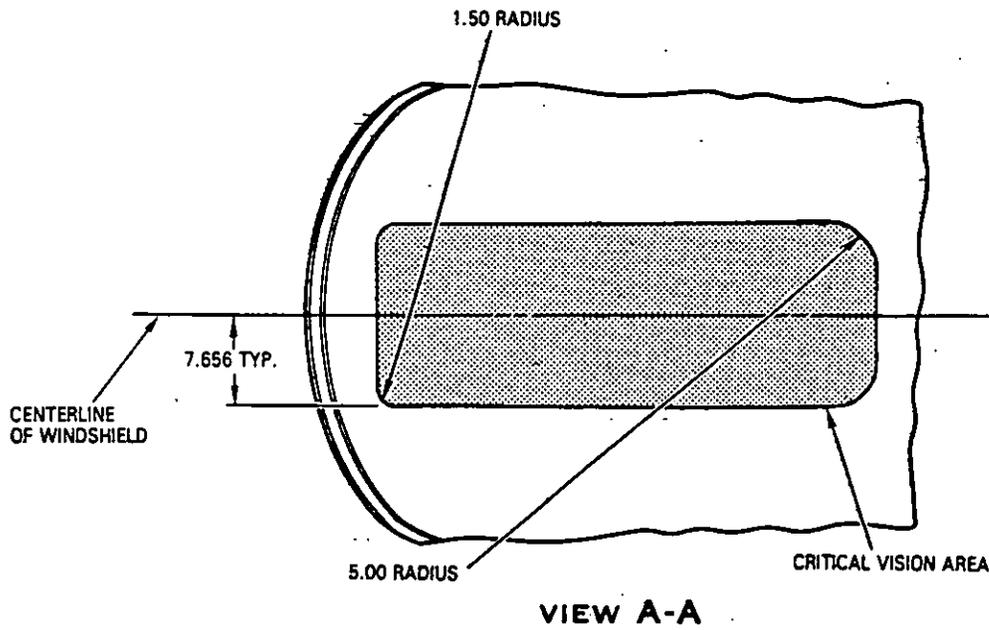
On my evaluation of A/C 9025 I found a scratch approximately 4 inches long at the 11 o'clock position on the windshield, near the windshield arch (Atch 3). Through visual inspection I found no distortion, and therefore there is no visual distortions. I then inspected the canopy, I found a few scratches that look like they may have come from a pilots helmet, but determined that they would be out of the pilots view area, and there was not any distortion.

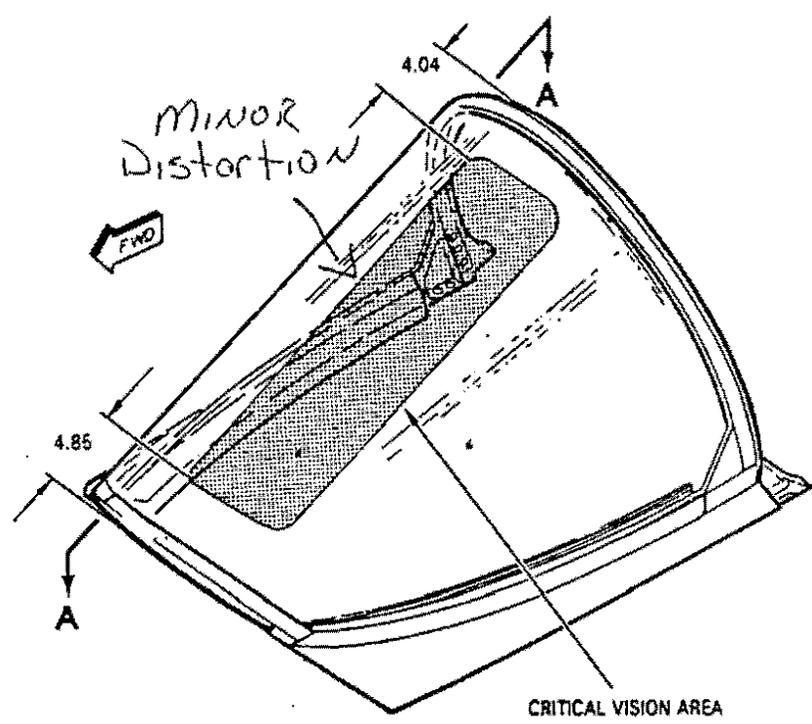
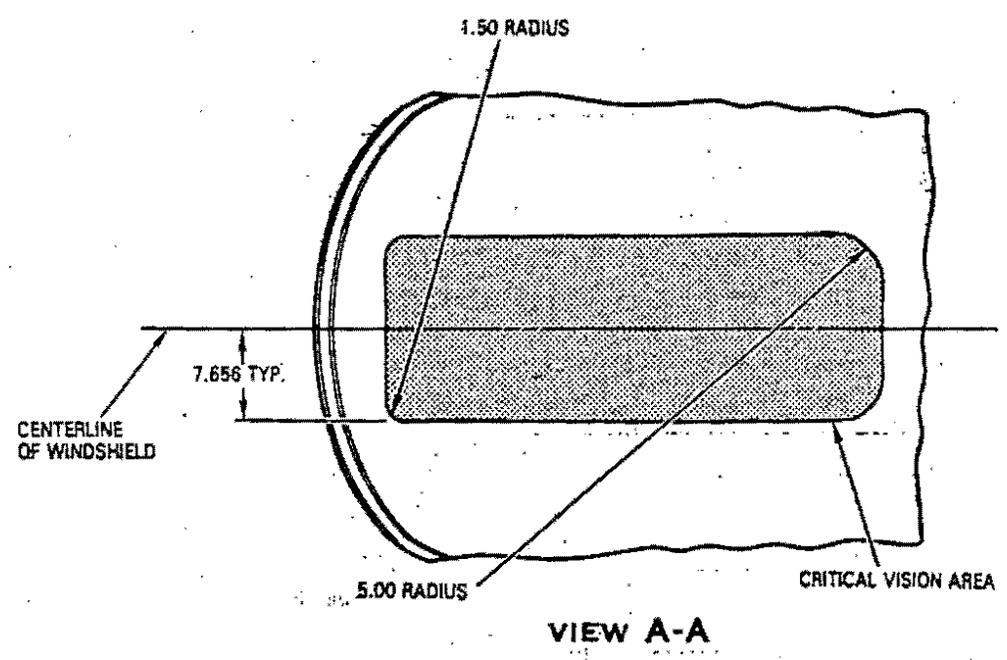
A/C 4025

I then inspected A/C 4025. Upon inspection I found a small distortion in the windshield at about 12:10 position. This was about half way down the windshield in the critical view area (Atch 4). I was not sure if it was a distortion or not so I examined the canopy and found the same thing I found on A/C 9025, and that was a few scratches but no distortions. I then went back and looked at the windshield again to make sure the distortion was still there and it was still there. Upon further inspection I determined that it was a small area not an area where a pilot would be able to focus in on for a long period of time.

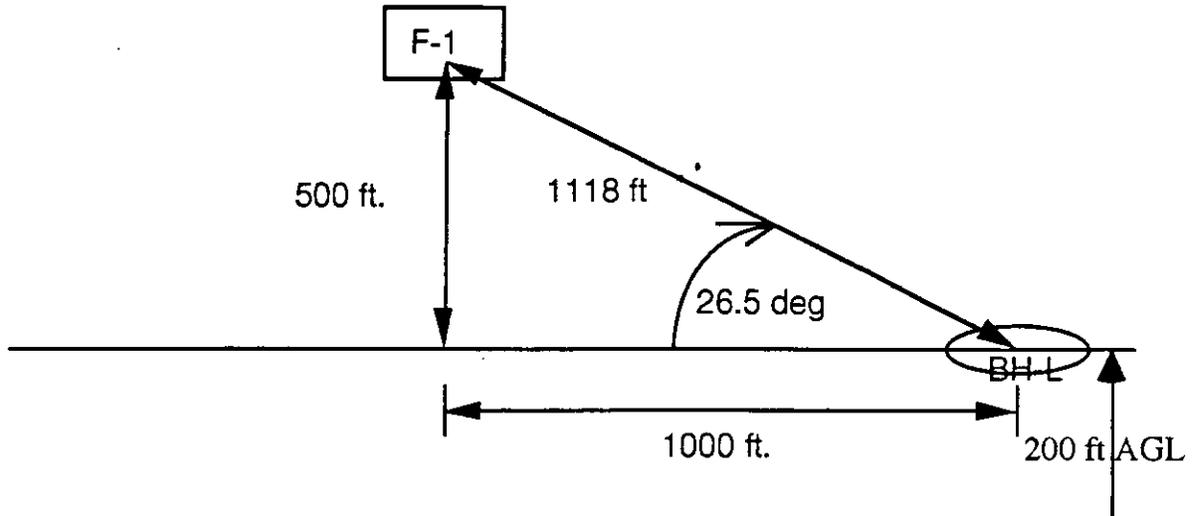
Figure 1. F-1 is at a slant range of 1118 feet from BH-L and the look down angle is 26.5 degrees.

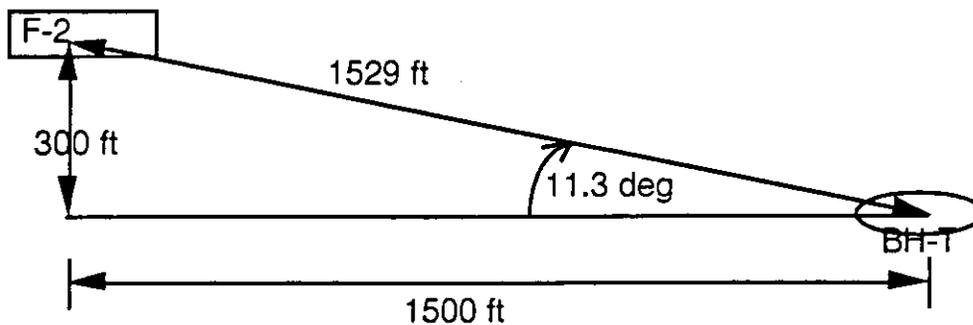
Figure 2. F-2 is at a slant range of 1529 feet from BH-T, and the look down angle is 11.3 degrees.

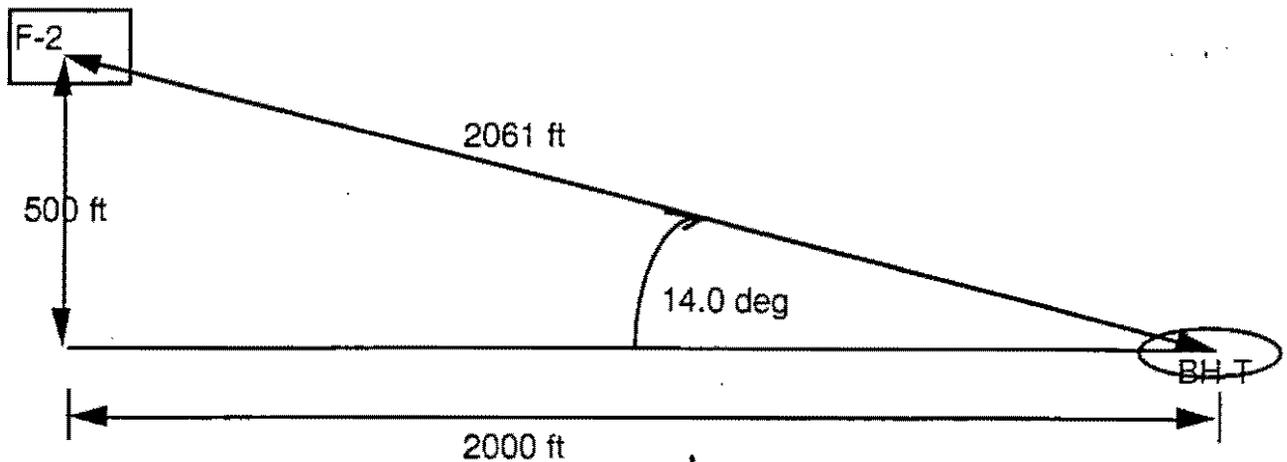
Figure 3. F-2 is at a slant range of 2061 feet from BH-T, and the look down angle is 14.0 degrees.
