Attached are the *Findings and Conclusions* and the *Recommendations* of the C-17 Executive Independent Review Team. Additionally, there are *Appendices* that provide definitions and background information.

James W. Mar
Chairman EIRT

FINDINGS & CONCLUSIONS

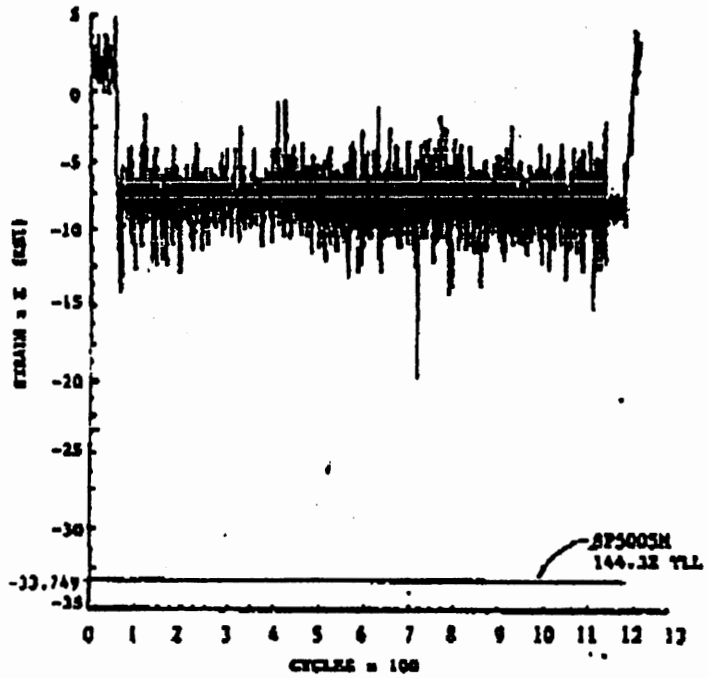
STRESSES IN UPPER SURFACE IN BAY 26

In the upper surface the maximum compressive stress is seen to be approximately 20 ksi in the durability article whereas it reached a shade under 34 ksi in the SP5005M test.

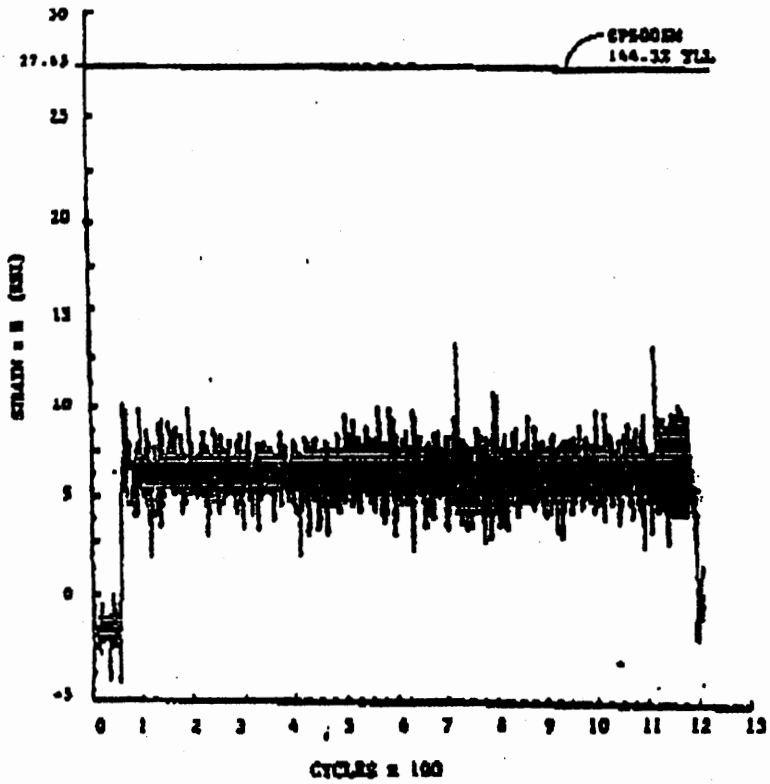
STRESSES IN LOWER SURFACE BAY 26

In the lower surface, the maximum tensile stress is seen to be approximately 12.5 ksi in the durability article whereas this same location reached almost 27.5 ksi in the SP5005M test.
