**AIRCRAFT
ACCIDENT INVESTIGATION BOARD
REPORT**

**US ARMY UH-60
BLACK HAWK HELICOPTERS
87-26000 AND 88-26060**

TECHNICAL REPORT F-15 MAINTENANCE

Aircraft Evaluated: F-15C, Tail Number 79-0025

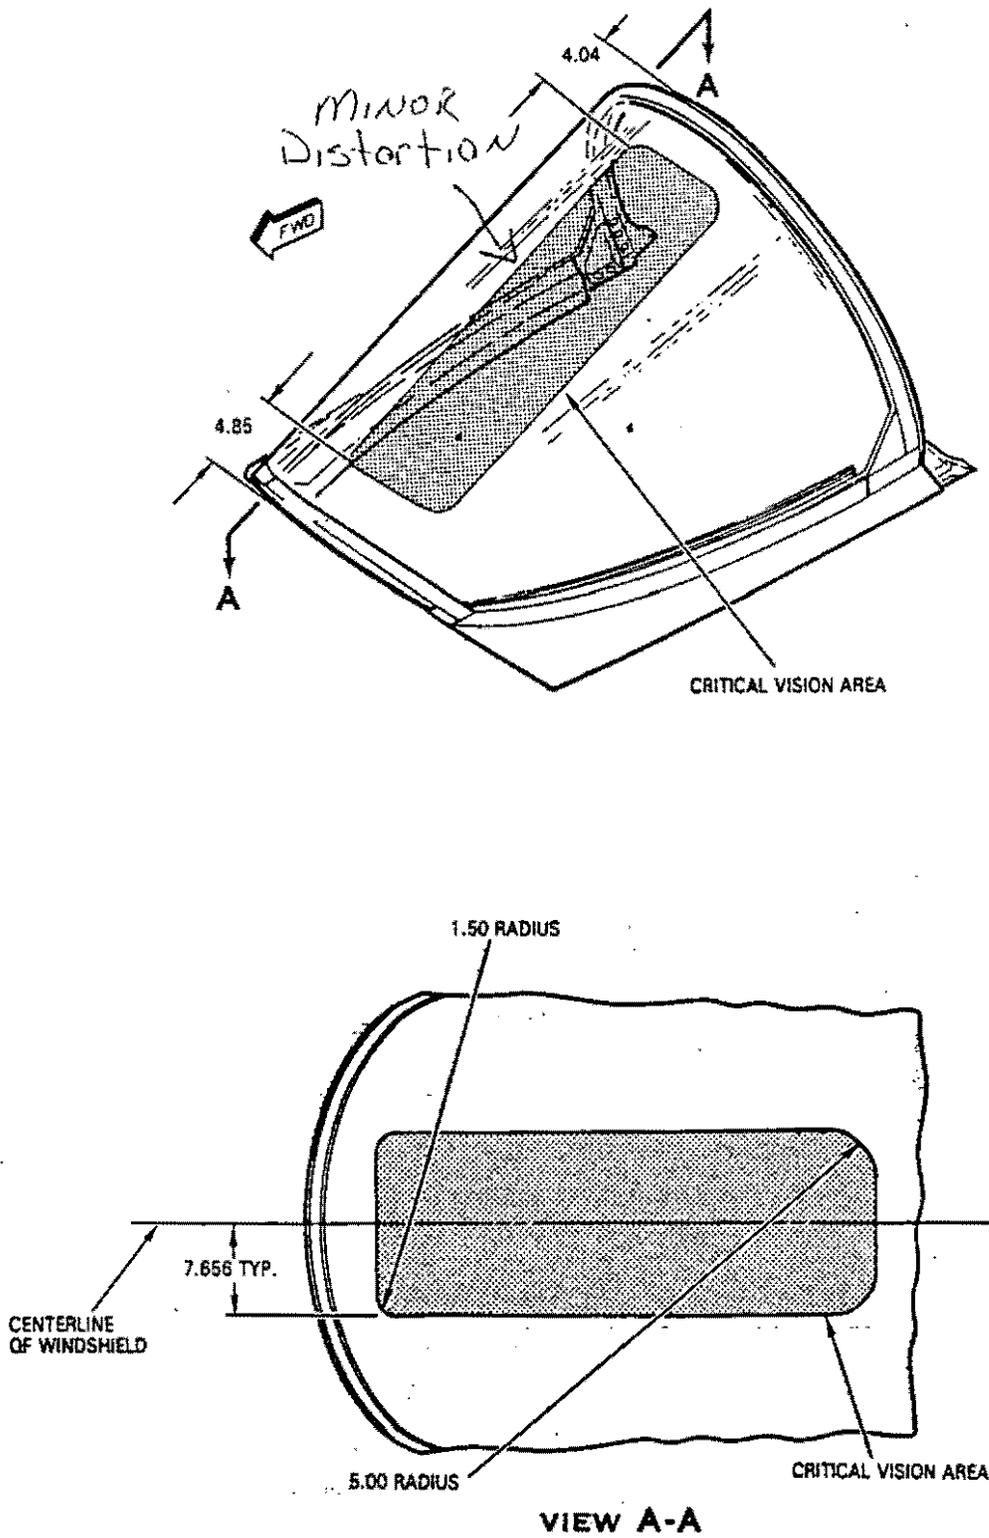
Figure 4-6B. Acrylic Transparency Rework Diagram, 68A350016

On my evaluation of A/C 9025 I found a scratch approximately 4 inches long at the 11 o'clock position on the windshield, near the windshield arch (Atch 3). Through visual inspection I found no distortion, and therefore there is no visual distortions. I then inspected the canopy, I found a few scratches that look like they may have come from a pilots helmet, but determined that they would be out of the pilots view area, and there was not any distortion.

I then inspected A/C 4025. Upon inspection I found a small distortion in the windshield at about 12:10 position. This was about half way down the windshield in the critical view area (Atch 4). I was not sure if it was a distortion or not so I examined the canopy and found the same thing I found on A/C 9025, and that was a few scratches but no distortions. I then went back and looked at the windshield again to make sure the distortion was still there and it was still there. Upon further inspection I determined that it was a small area not an area where a pilot would be able to focus in on for a long period of time.

Overall I found that both A/C's canopy's and windshield's were in very good condition. The canopy and windscreen are within limits IAW T.O. 1F-15C-3-4 on both aircraft.

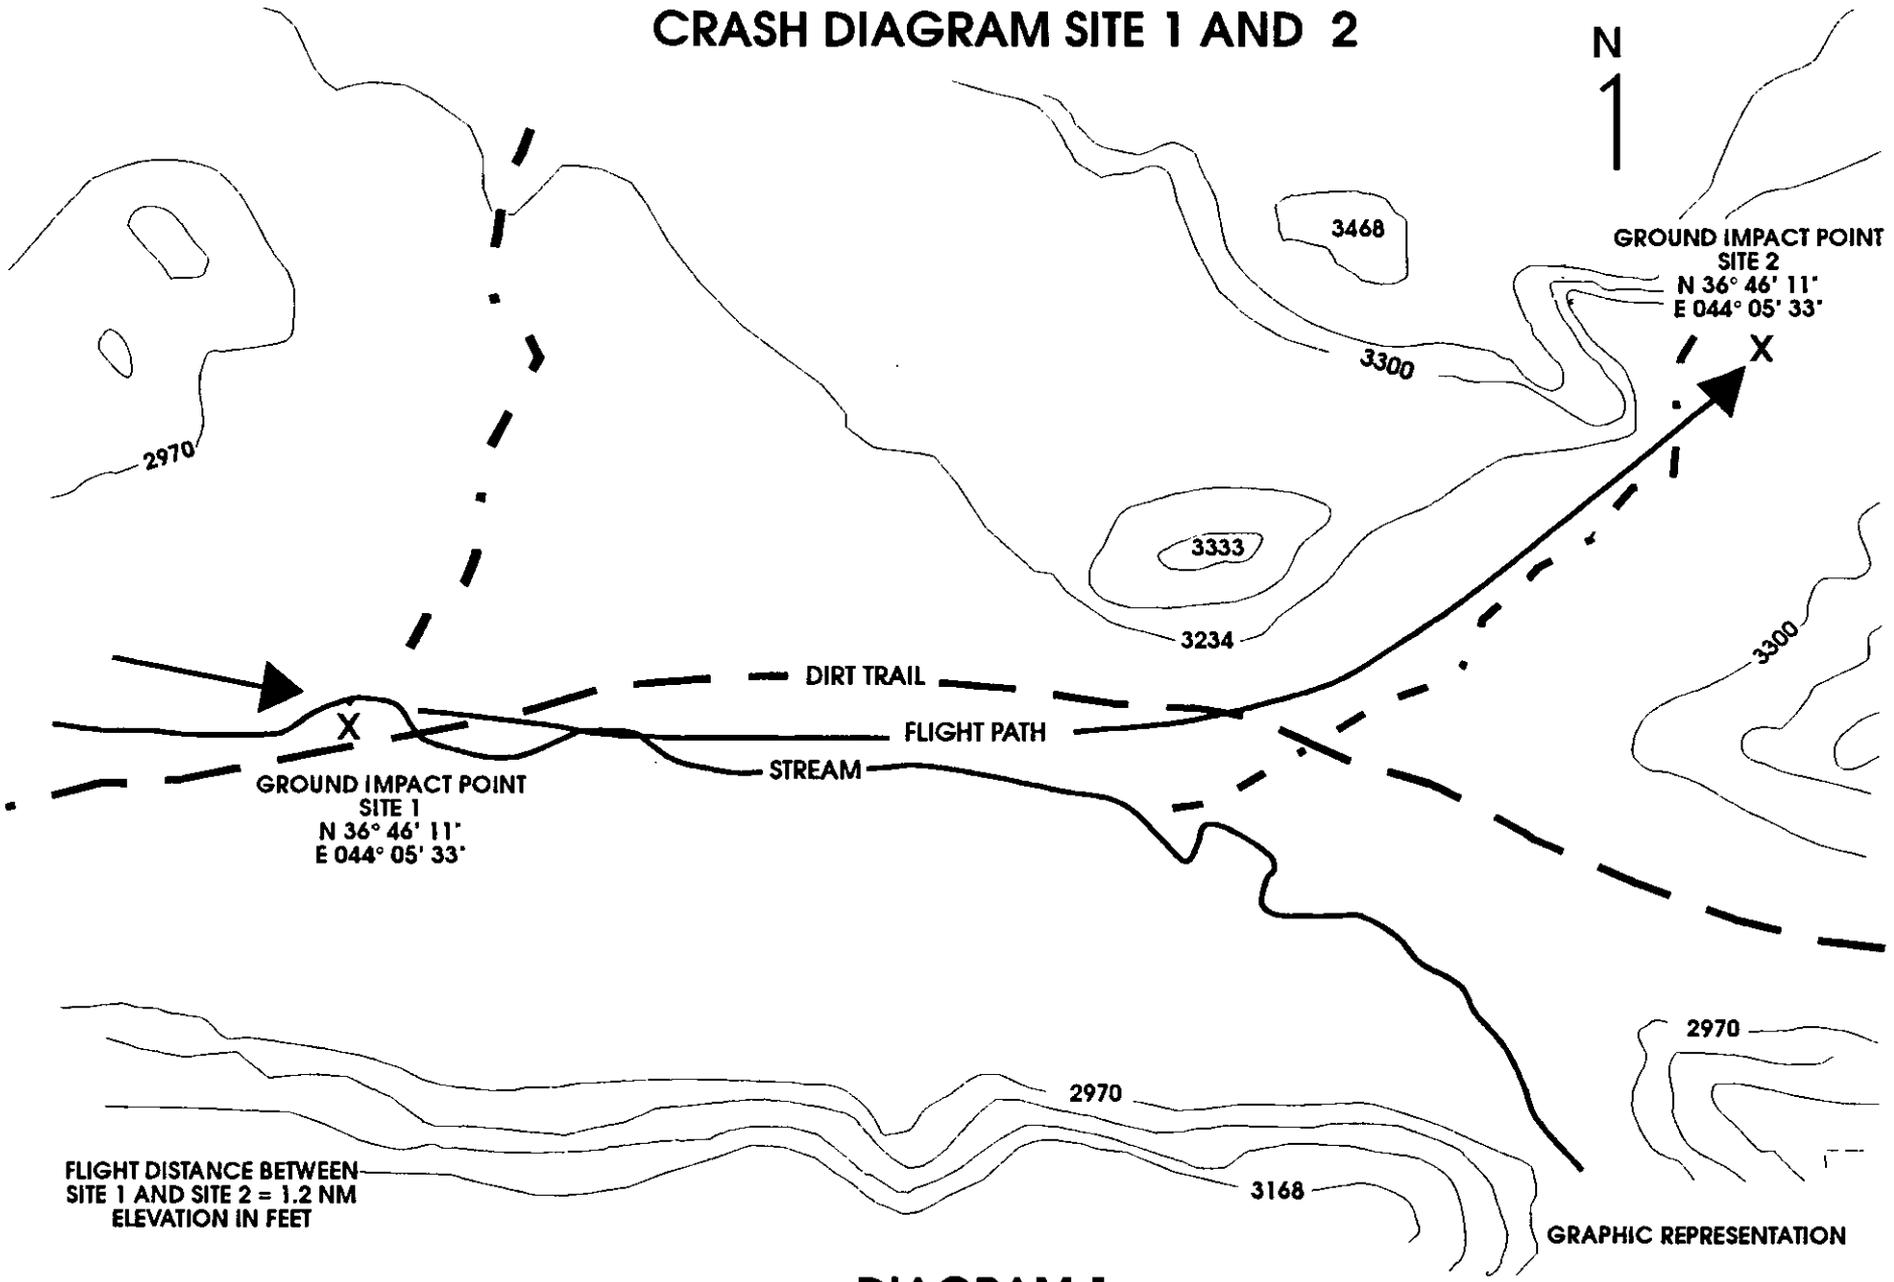
CRASH DIAGRAM SITE 1 AND 2

FLIGHT DISTANCE BETWEEN
SITE 1 AND SITE 2 = 1.2 NM
ELEVATION IN FEET

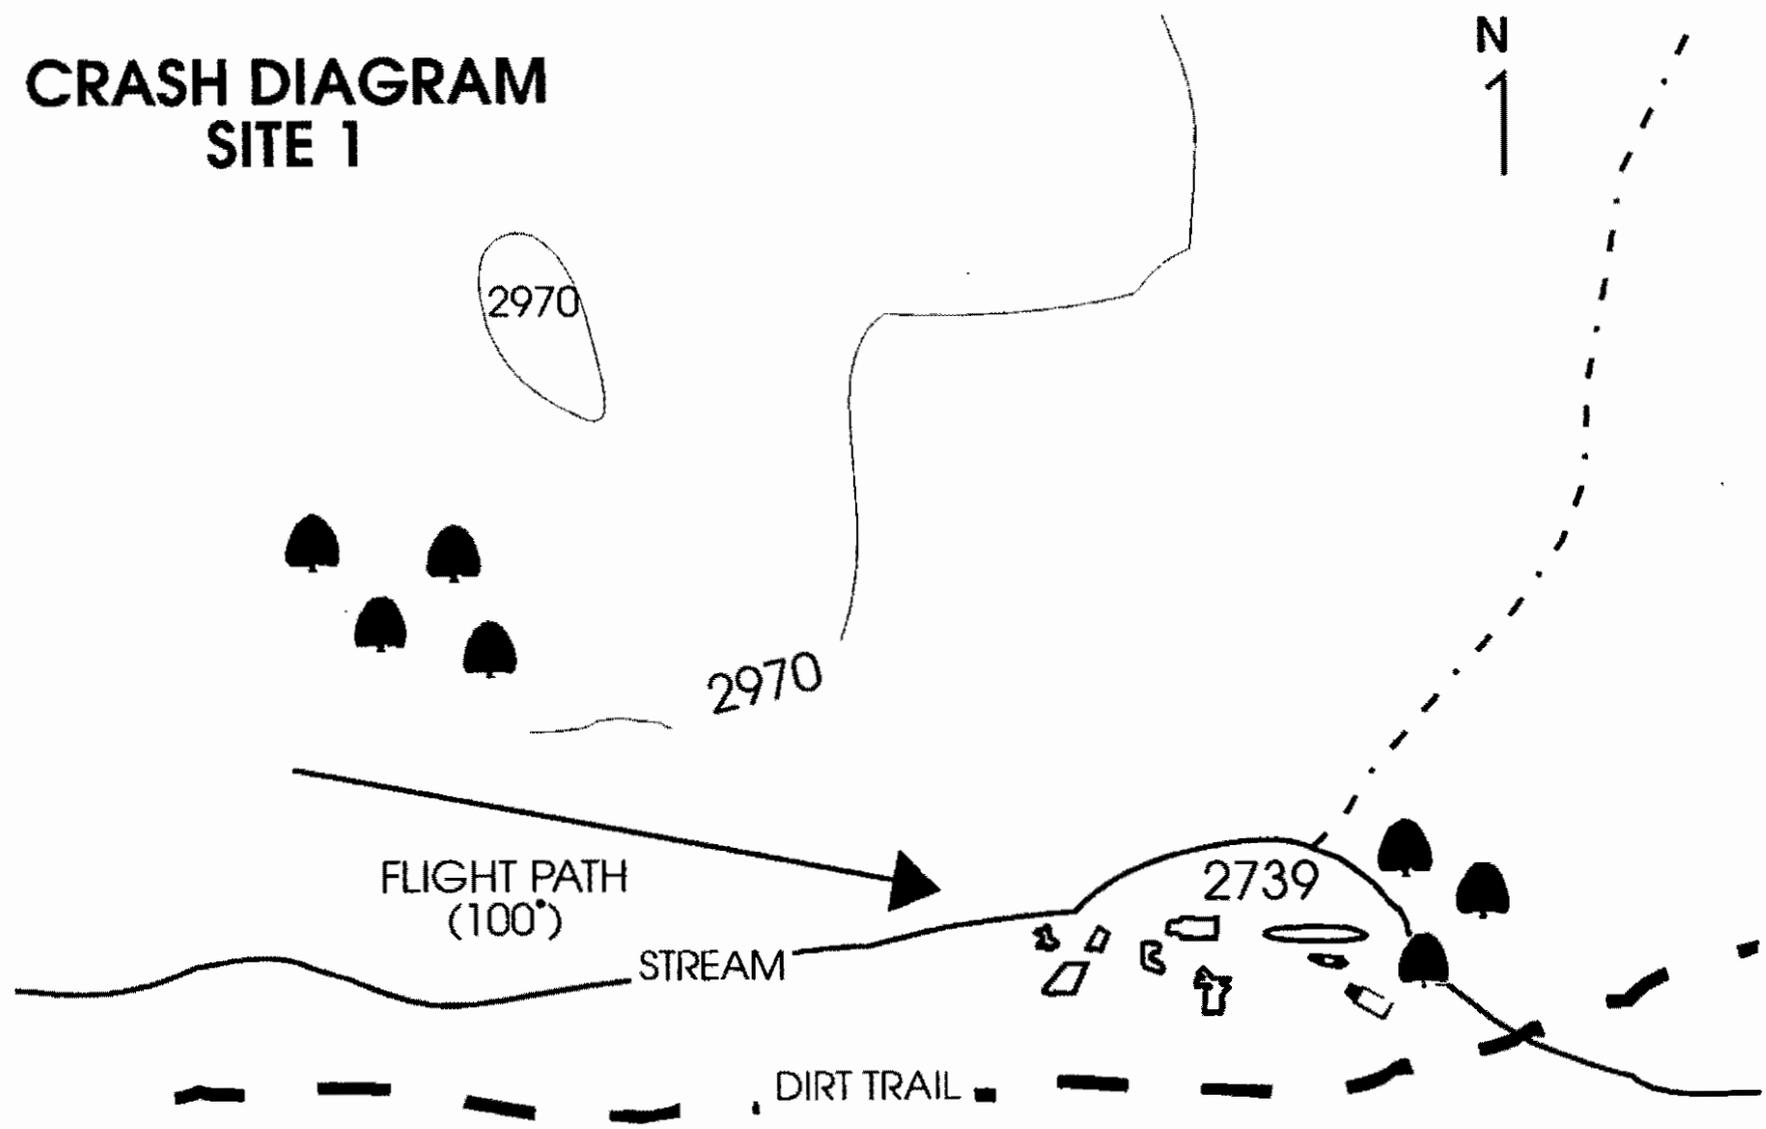
CRASH DIAGRAM SITE 1

GROUND IMPACT POINT
SITE 1
N 36° 46' 04"
E 044° 05' 33"

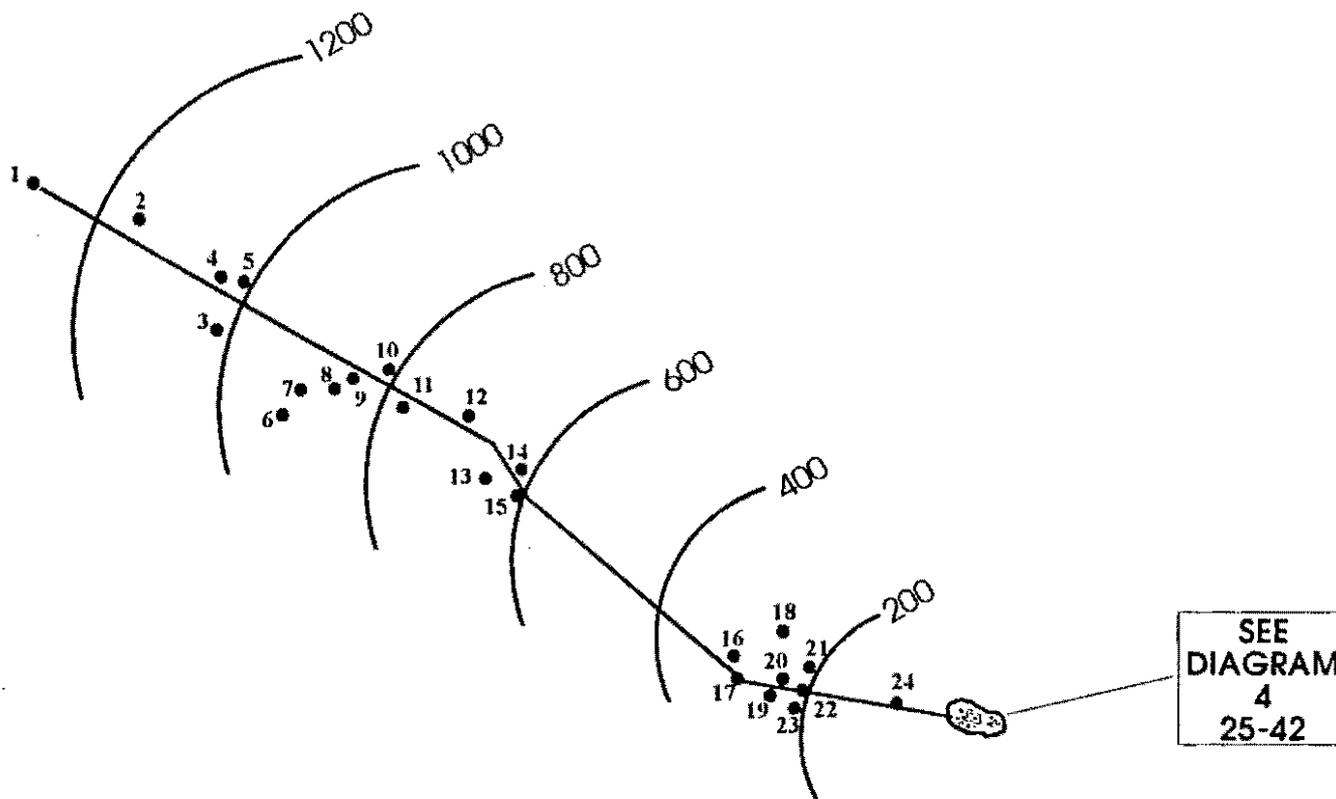
DIAGRAM 3

ITEM	DESCRIPTION	DIST (FT)	DIR (MAG)
1	CHAFF	1320	119
2	CARGO DOOR WINDOW	1200	121
3	SOUND PROOFING, PASS. CPMT	1110	116
4	TOP FUSelage COVERING VCTY TAIL BOOM	1095	120
5	AFT PIECE OF LEFT CARGO DOOR	1050	122
6	SLEEPING BAG	1020	113
7	VOR ANTENNA	996	116
8	PIECE OF SEAT BELT	936	117
9	SOUND PROOFING, CARGO CPMT	936	118
10	LEFT APU ACCESS DOOR (CUT)	915	121
11	RIGHT APU ACCESS DOOR	873	120
12	APU FIRE DETECT LITE	825	121
13	FUEL CAP RIGHT SIDE	762	121
14	COWLING BEHIND FIRE BOTTLES	690	116
15	SOUND PROOFING, PASS. CPMT	684	115
16	APU COMPARTMENT FIREWALL	660	113
17	APX 15B ANTENNA CABLE	360	105
18	PIECE APU INTAKE HOUSING	324	096
19	PIECE APU COMBUSTION CHAMBER	300	102
20	PIECE FUSELAGE SIGN (SMALL)	294	097
21	PIECE FUSELAGE SIGN (SMALL)	258	101
22	ELECTRICAL WIRE (10' LONG)	258	100
23	APU ENGINE PART	258	094
24	TAIL BOOM SECTION, LEFT SIDE	129	100
25-42	MAIN WRECKAGE CENTER OF MASS	0	0
43	PIECE OF MISSILE	497	100

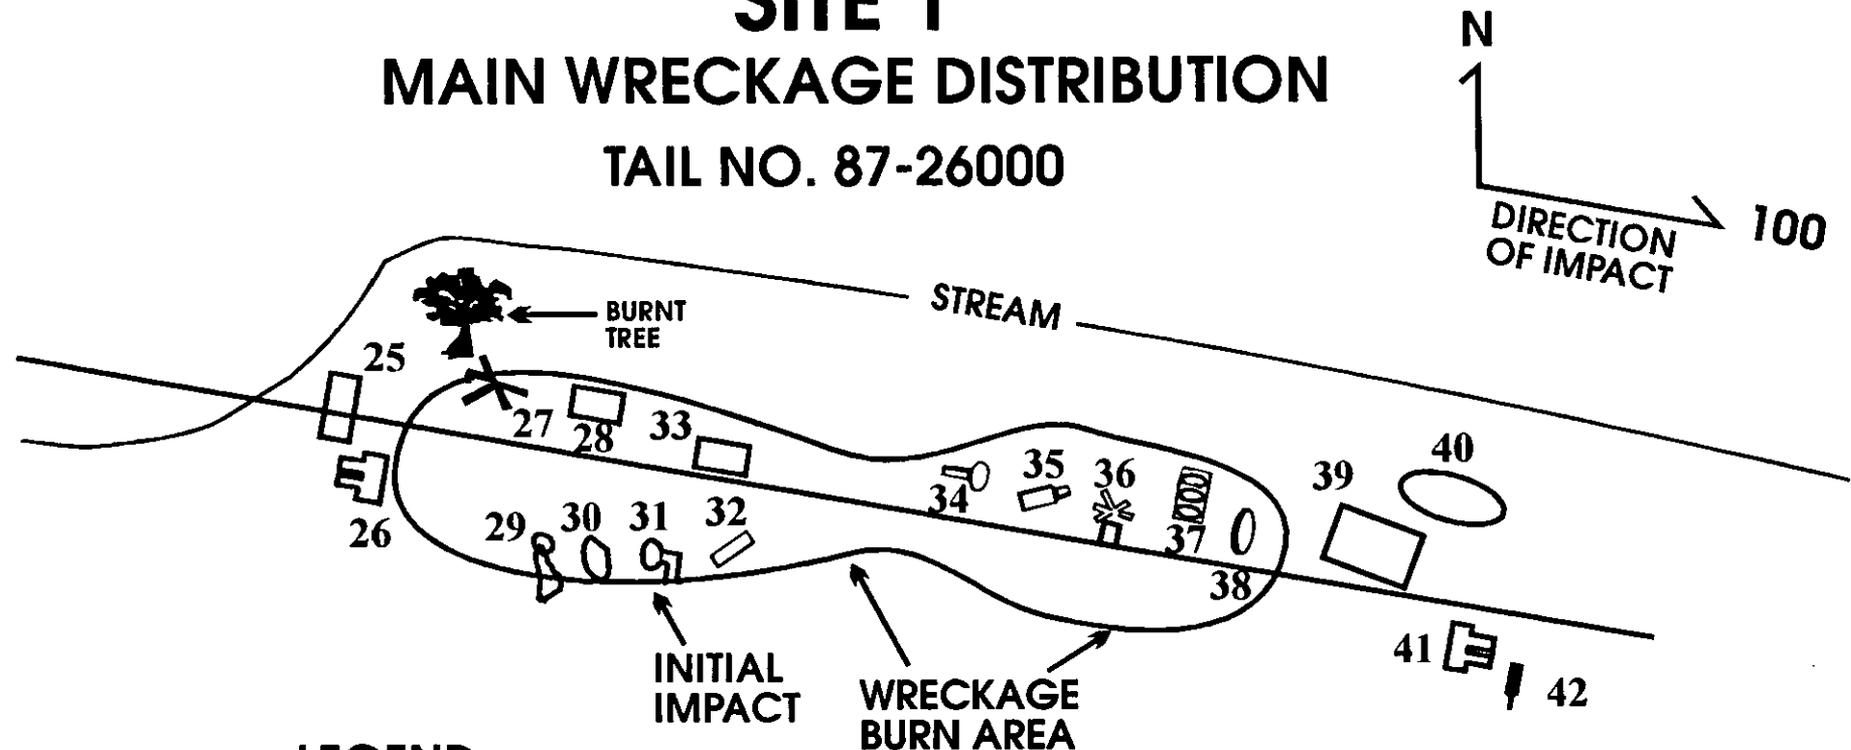
MAIN WRECKAGE DISTRIBUTION

ITEM	DESCRIPTION	DIST (FT)	DIR (MAG)
25	RIGHT STABILATOR PART	96	290
26	LEFT ESSS PART	98	280
27	TAIL ROTOR PYLON	56	275
28	TAIL BOOM PART	53	278
29	LEFT WHEEL STRUT	51	255
30	SEARCH LITE	50	258
31	PEDAL, TAIL ROTOR CONTROL	50	258
32	MAIN ROTOR BLADE PART	40	300
33	TAIL BOOM PART	43	278
34	OIL COOLER FAN	15	300
35	LEFT ENGINE	5	300
36	MAIN TRANSMISSION	0	0
37	HYDRAULIC ASSIST MODULE	10	110
38	SLEEPING BAG	13	112
39	CARGO FLOOR PIECE	30	115
40	RIGHT ESSS FUEL TANK	47	108
41	RIGHT ESSS PYLON	75	120
42	RIGHT ENGINE	88	120
