# NEWS BRIEFING

**Secretary of Defense William J. Perry**  
**General John Shalikashvili, USA, Chairman of the Joint Chiefs of Staff**  
**Major General James Andrus, USAF, 3rd Air Force Commander**  
**Ms. Kathleen M. deLaski, ATSD (PA)**  
**Wednesday, July 13, 1994 - 2:15 p.m.**

We are here today to present you with the findings of the Department into the circumstances surrounding the tragic incident in Northern Iraq in which two of our fighters accidentally shot down two of our helicopters.

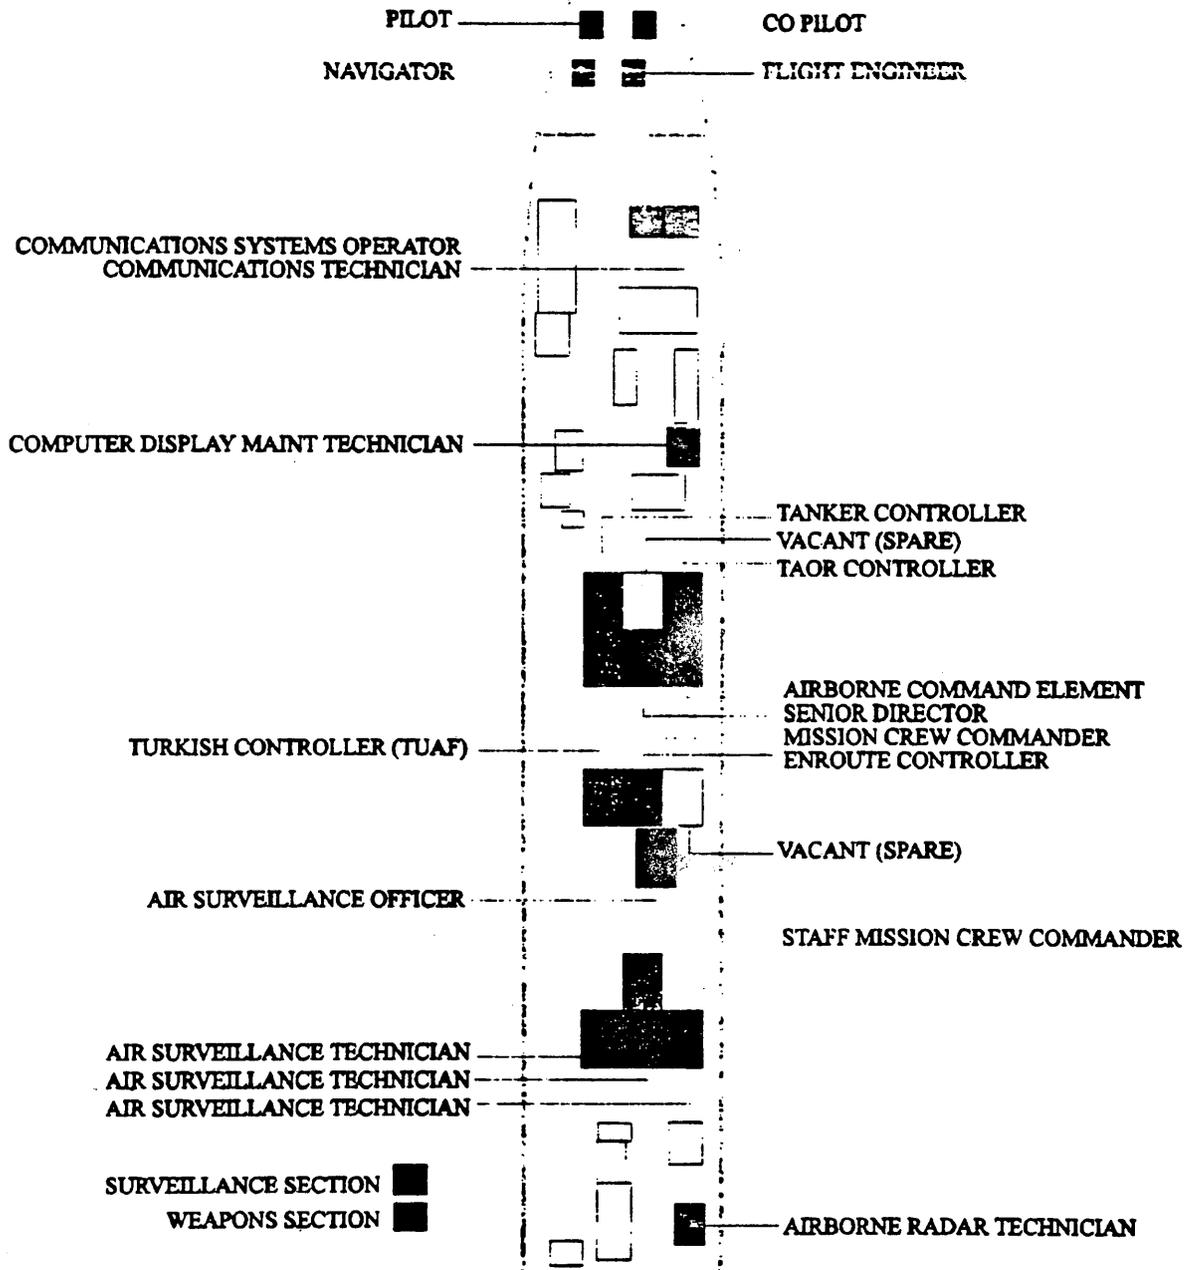
Figure 2 (AWACS Layout)

The airborne command element (ACE) is also on board. He is the CFACC's representative and works directly with the mission crew commander and SD. CTF PROVIDE COMFORT OPLAN 91-7 provides that, "An airborne command element (ACE) will be aboard [AWACS] to serve as the representative of the CFACC for time critical decisions."<sup>61</sup> CFAC operating instructions for the ACE provide that the ACE will act as the "eyes and ears" of the CFAC DO in the execution of the combat operations. They provide that the ACE has primary responsibility for the mission outside of a 50 NM circle of Incirlik, but emphasize that reference should be made to the CFAC DO. They imply that actions required for emergency or unsafe conditions can be taken by the ACE, who would then contact the CFAC DO as soon as possible.<sup>62</sup> The CFACC, in his testimony, stated that the ACE had no decision-making authority.<sup>63</sup>

# E-3B AWACS

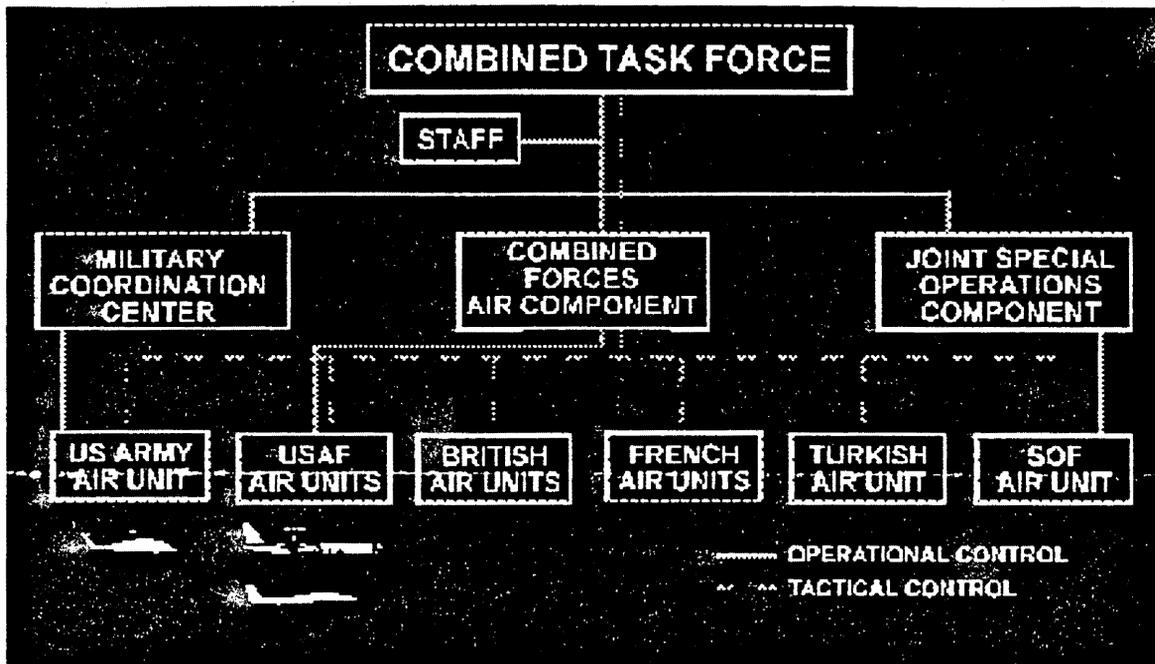
THIS GRAPH SHOWS THE ORGANIZATION ON THE 14TH OF APRIL 1994.

ACCORDING TO HIGHER HEADQUARTERS DIRECTIVES, THE COMBINED TASK FORCE COMMANDER HAD OPERATIONAL CONTROL OF THE US AIRCRAFT AS SHOWN BY THE SOLID LINE. OPERATIONAL CONTROL OF OTHER COALITION FORCES WAS RETAINED BY THEIR RESPECTIVE NATIONS.

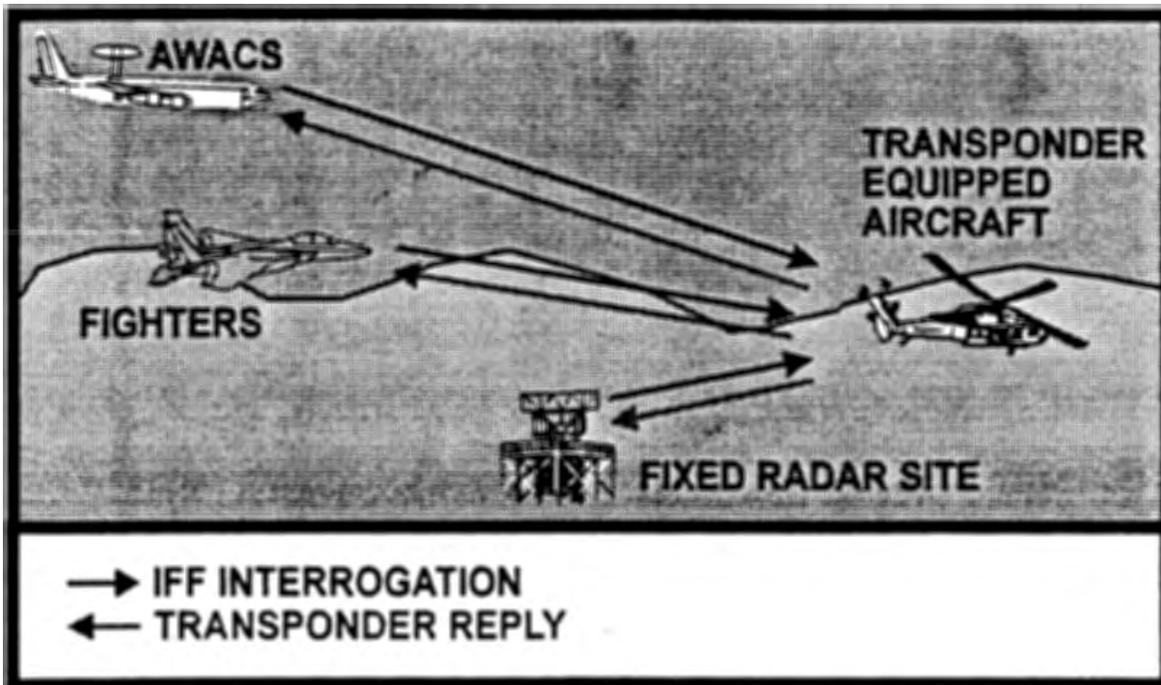
FACT SHEET  
INFORMATION FRIEND OR FOE (IFF) SYSTEM

THE IFF SYSTEM IS USED TO IDENTIFY INDIVIDUAL AIRCRAFT OR FLIGHTS, PARTICIPATING IN OPERATION PROVIDE COMFORT. THERE ARE TWO INTERACTING COMPONENTS OF THE SYSTEM: A TRANSPONDER AND AN INTERROGATOR. EACH COALITION AIRCRAFT IS EQUIPPED WITH AN IFF TRANSPONDER. WHEN THE TRANSPONDER IS INTERROGATED FROM A GROUND OR AIRBORNE SOURCE, IT WILL RESPOND WITH A NUMERICALLY IDENTIFIABLE PULSE. EACH TRANSPONDER CAN REPLY IN SEPARATE MODES. EACH MODE CAN BE PROGRAMMED TO REPLY WITH A SEPERATE NUMERIC CODE. THESE REPLIES ARE DISPLAYED ON A RADAR SCOPE.

<u>MODE</u>	<u>CODE</u>	<u>OPC AIRCRAFT</u>
I	42	HELICOPTER OUTSIDE TAOR
	43	FIXED WING OUTSIDE TAOR
	52	ALL AIRCRAFT INSIDE TAOR
II	5530	BLACKHAWK LEAD
	5531	BLACKHAWK WING
IV	ENCRYPTED	ALL AIRCRAFT
